Leaching Study of Coated Wood Pilings in Saltwater

Beth Stokes¹, Emily White¹, Mike Sanders¹, Kevin Ragon^{1,2}, Grady Brafford³

¹Mississippi State University, ²Southern Pressure Treaters' Association, ³Lonza Wood Protection/Arxada

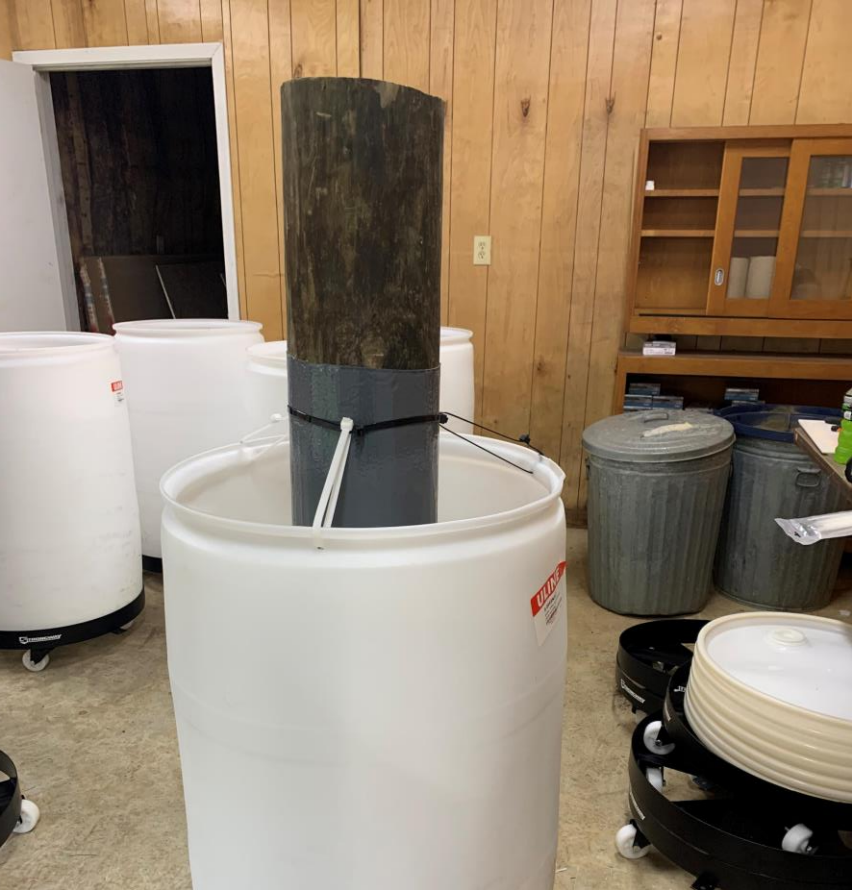
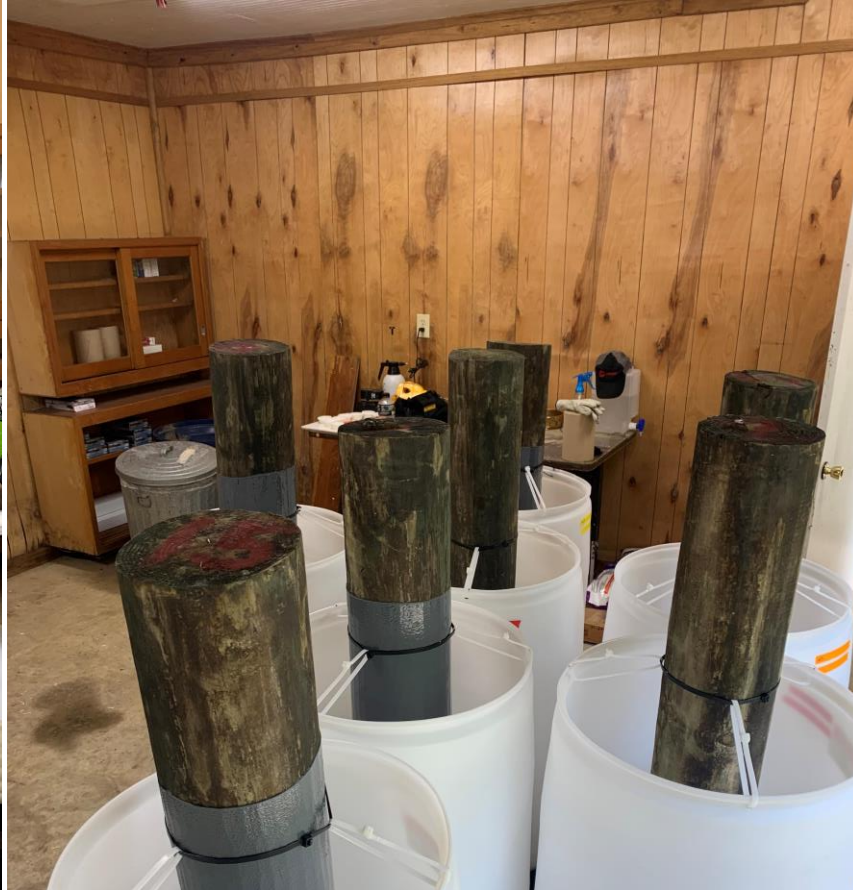
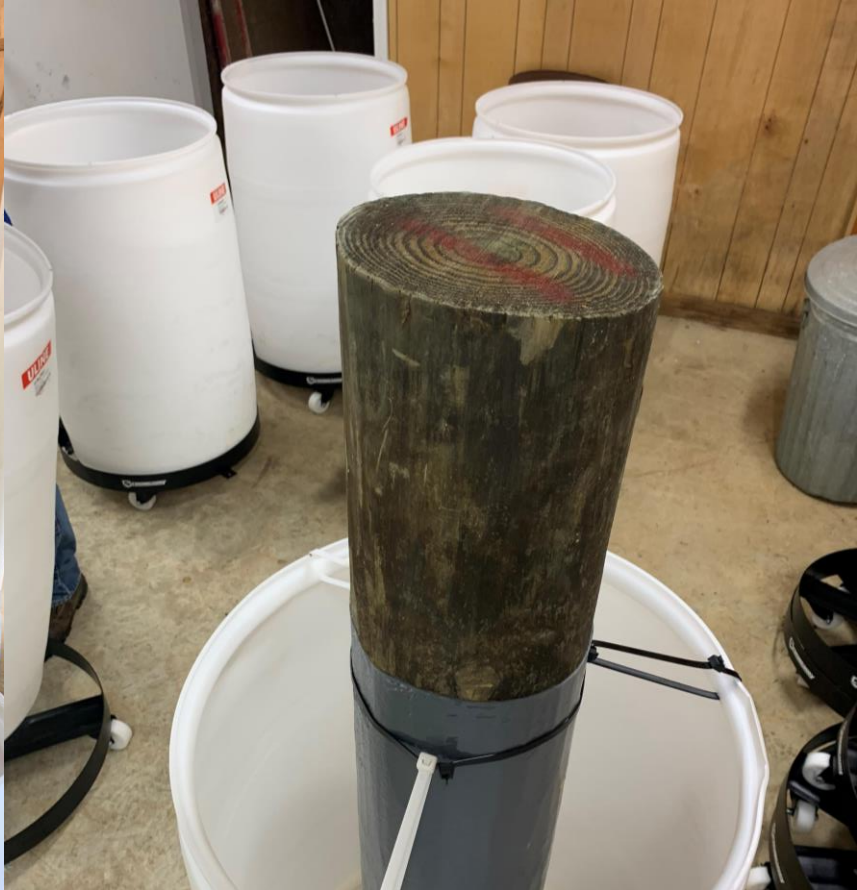
Installation

Pilings

- 8 in. diameter, 5 ft length SYP pilings were treated with CCA to 2.5 pcf by Lonza/Arxada
- Pilings were then coated with UL XP 6613 (A-side or B-side) from Ultimate Linings
- Pilings were delivered to the Dorman Lake Field Site testing facility at Mississippi State University and stored in controlled conditions in the Termite House until testing began

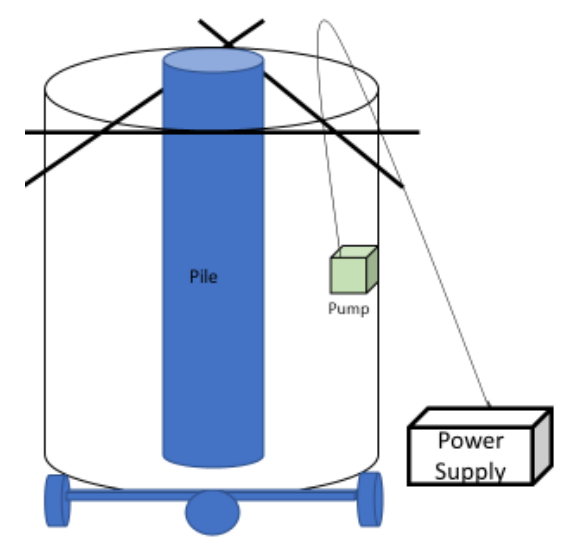
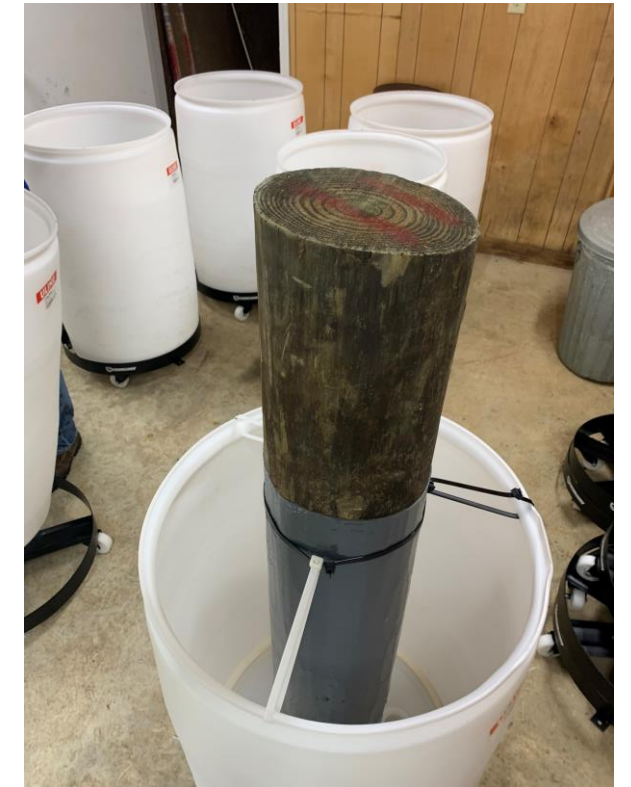
Experimental Plan

- 55-gallon drums were procured and placed on rolling drum dollies.
- Anchor holes were drilled at three points around the top of each drum
- The center of each drum lid was cut out, and each drum lid was placed into the lower portion of the drum to act as a support.
- Pilings were placed through the cut lid, and positioned in the center of each drum.
- A 36" zip tie was secured around each piling, and three zip ties were secured through it and through one of the three anchor points.
- Drums were labeled with the piling's number for identification

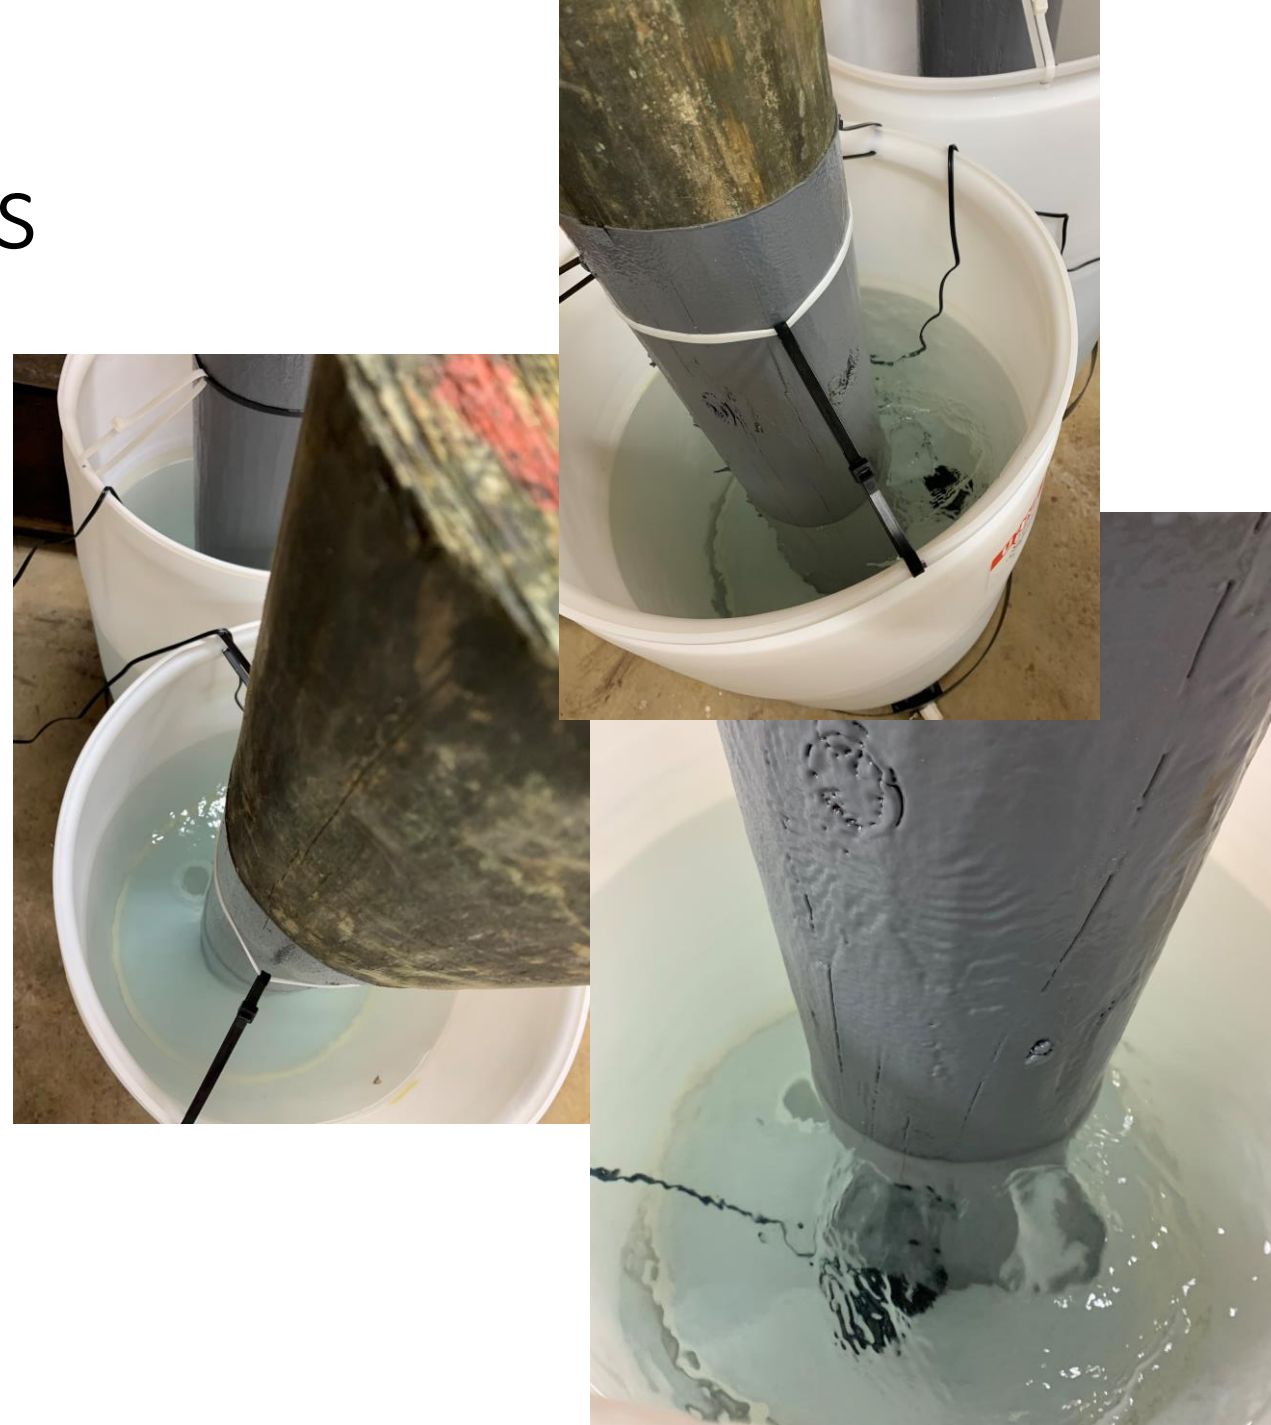
Results – Coated Pilings

- After 3 months of collections, water remained mostly clear
- Checks, knots, and other pole defects were apparent through both coating types
- Although visible, defects do not seem to be causing an issue

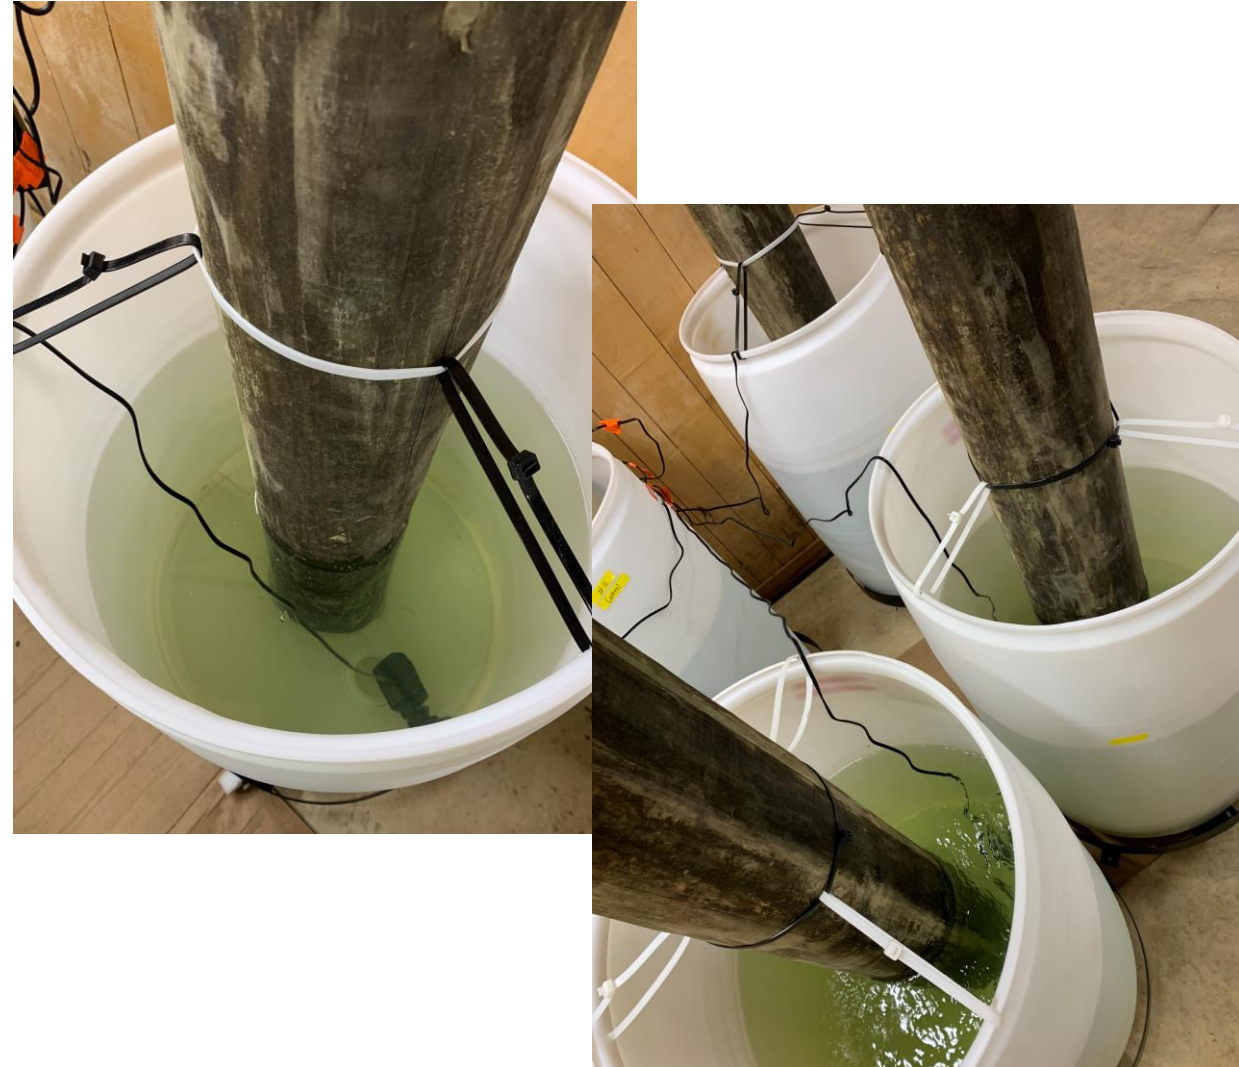
Results – Uncoated Pilings

- After 3 months of collections, water in all containers had a green coloration
- Not algae – water was sampled to look for algal cells
- Discoloration present in ALL uncoated piling drums

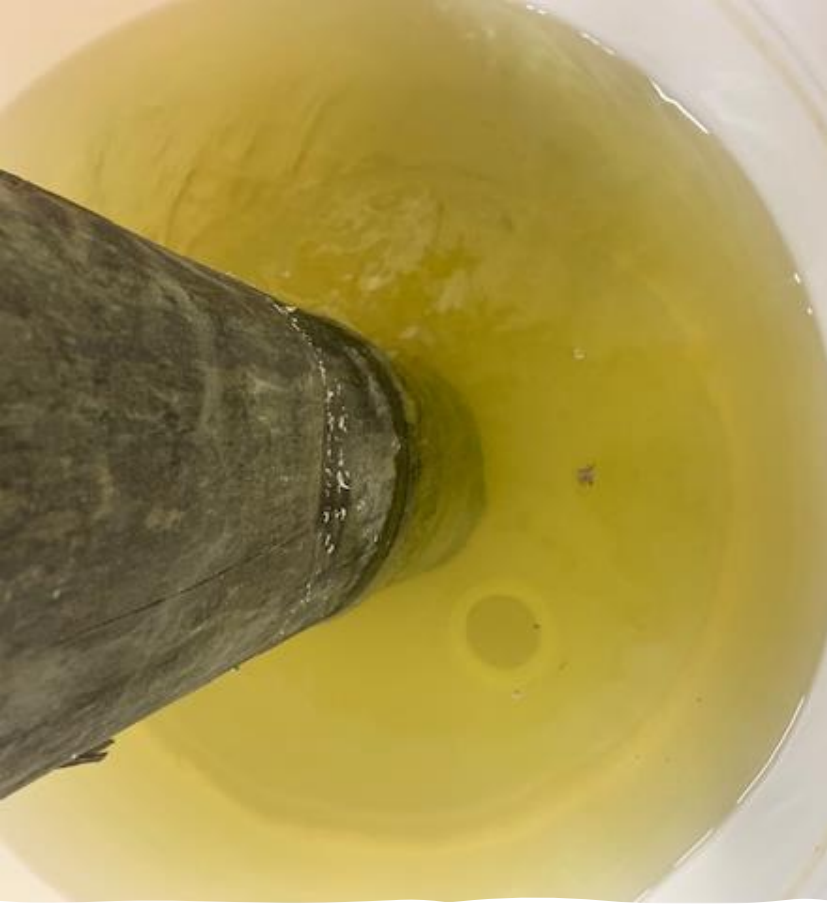
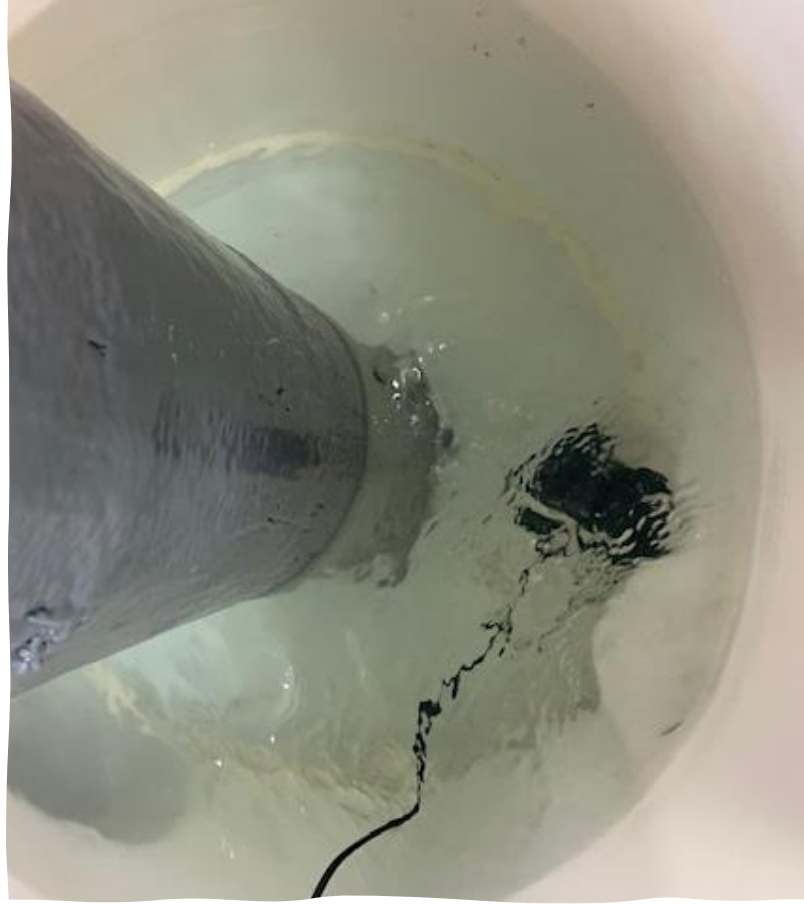
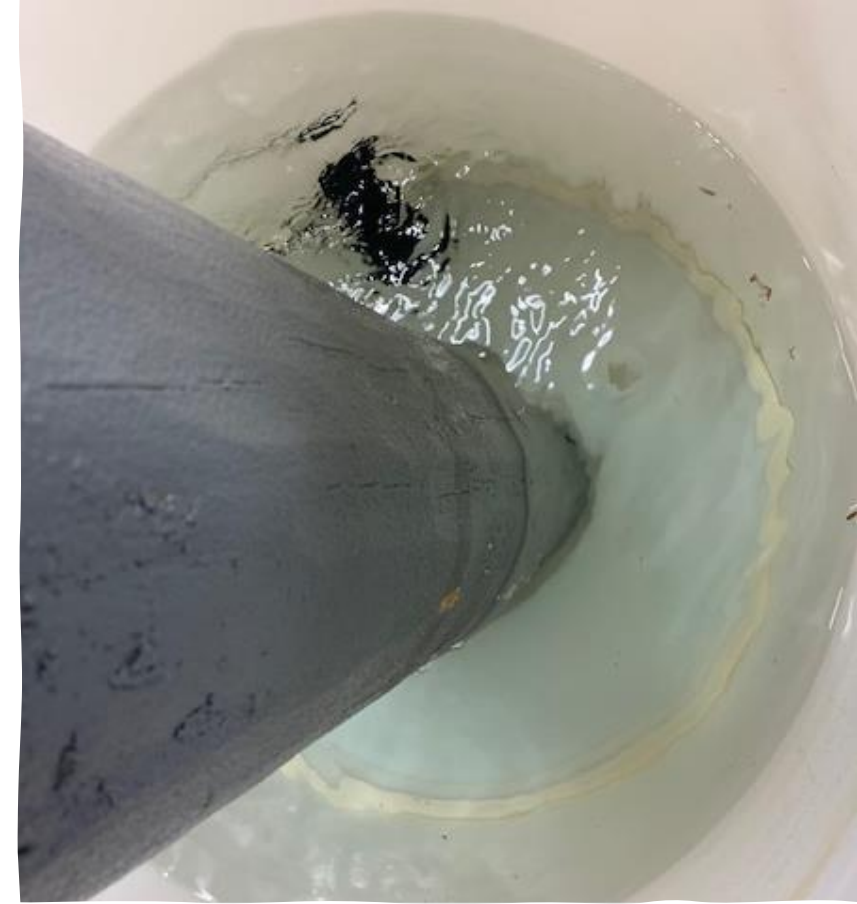
Results – Coated and Uncoated 6 Months

- Strong discoloration of water in uncoated piling tanks
- Surface discoloration of uncoated pilings at water line
- Salt deposits most common on uncoated pilings

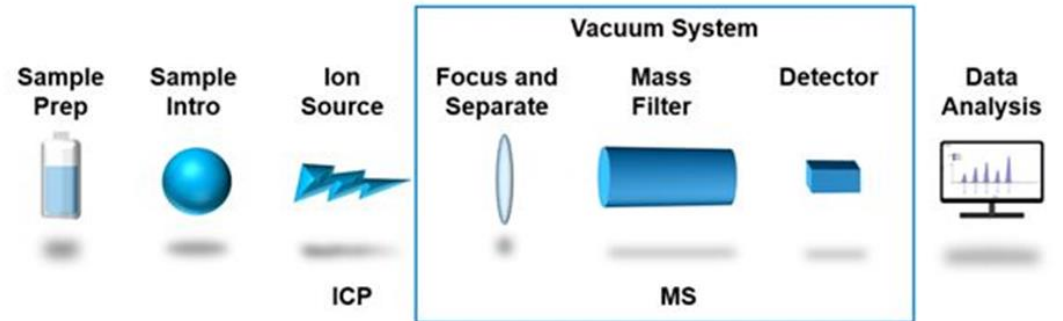
What does ICP-MS do?

- Uses argon plasma to convert elements in an introduced sample to ions
- Focuses and separates ions from “other” signals
- Filters ions by mass
- Detects how many ions interact per second with detector
- Analyzes information, gives counts/second or concentration (mg/L)

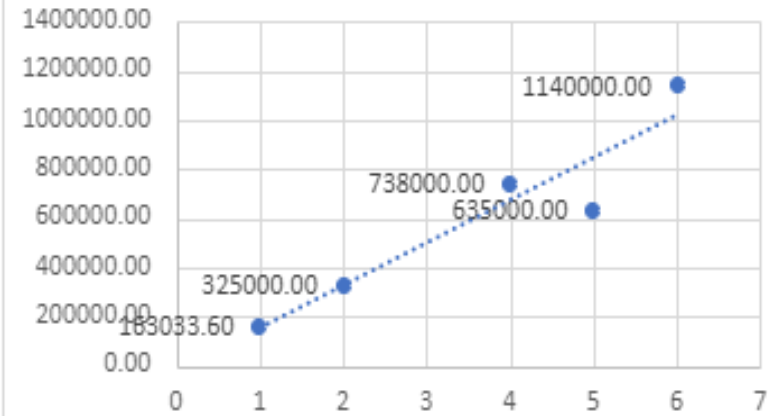
Control Cr52

ICP-MS Data - Chromium

- Water samples from uncoated control samples increased in chromium content an order of magnitude more rapidly than coated samples.
- Water samples from coating group A are increasing in chromium content slightly more than water samples from coating group B.
- Last three readings of ICP-MS produced inconclusive data
 - MS State Chemical Lab will repeat analysis
- Levels of chromium, copper, and arsenic are low in water samples but still higher than EPA recommended acute limits
- Project will continue with updates/modifications

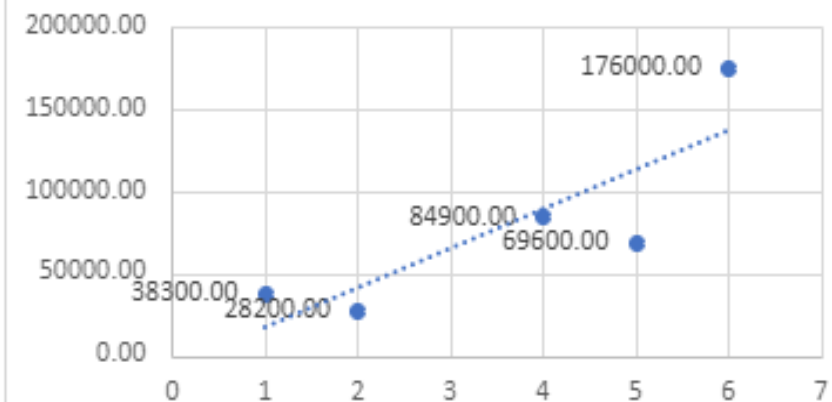
Control Cu63

ICP-MS Data - Copper

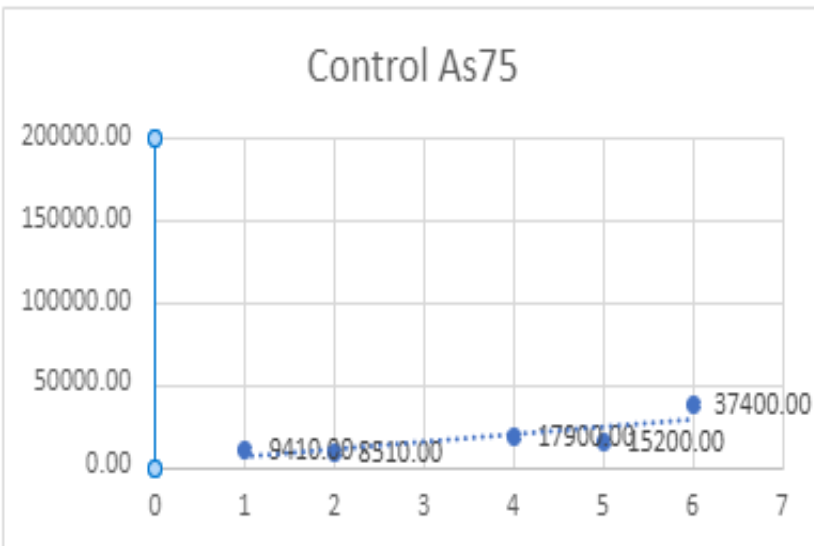
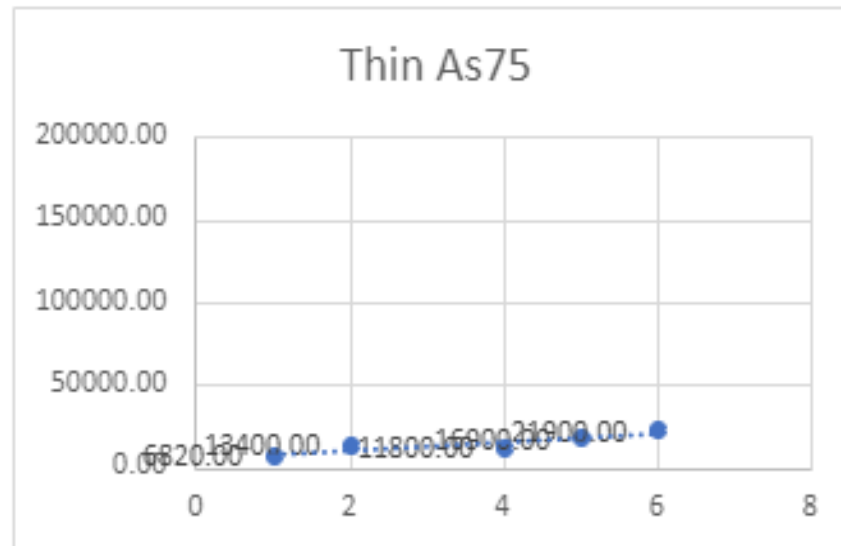
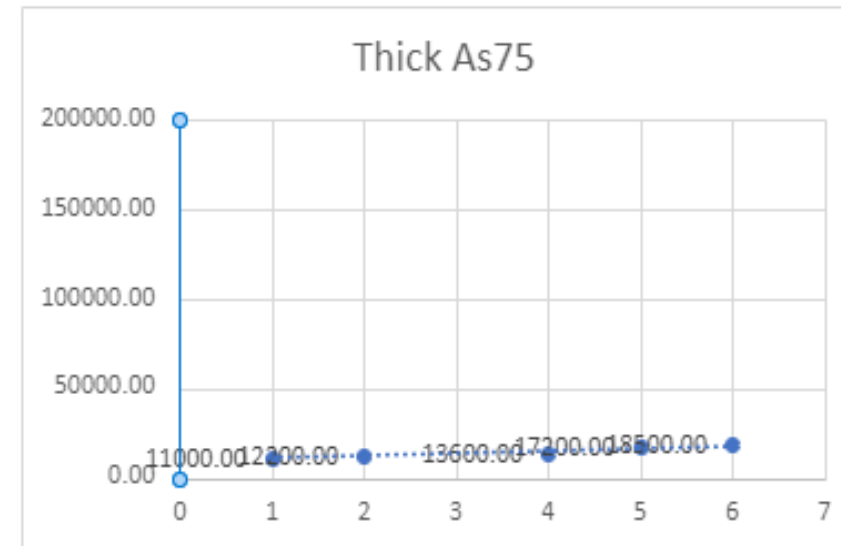
ICP-MS Data - Arsenic
